TECHNICAL NOTE

D-272

THERMAL-STRESS FATIGUE CRACKING OF TURBINE BUCKETS
OPERATED AT 1700° F IN A TURBOJET ENGINE WITH
LONG PERIODS OF OPERATION BETWEEN STARTS

NATIONAL AERONAUTICS AND SPACE ADMINISTRATION
WASHINGTON

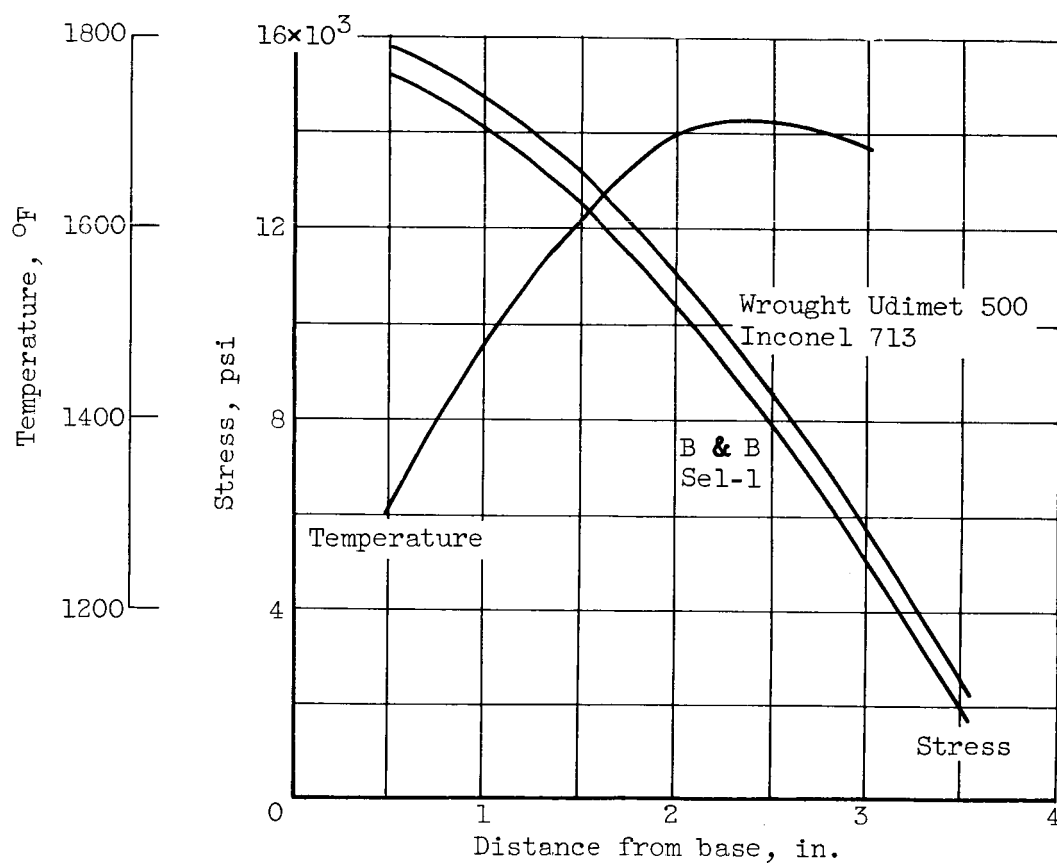
Figure 1. - Bucket stress and temperature distributions at rated conditions.

The centrifugal stress and temperature distributions in bucket airfoils at rated-speed and advanced-temperature conditions are shown in figure 1. The centrifugal stress was calculated, by the method of reference 5, using the bucket geometry, material density, and engine rotational speed.

The temperature distribution shown in figure 1 was obtained before the actual bucket investigation was initiated. To do this, the engine was first operated with U. S. Air Force stock S-816 alloy buckets for sufficient time to obtain equilibrium conditions at rated speed and 1700° F. Temperature measurements were then obtained from thermocouples imbedded in four turbine buckets.

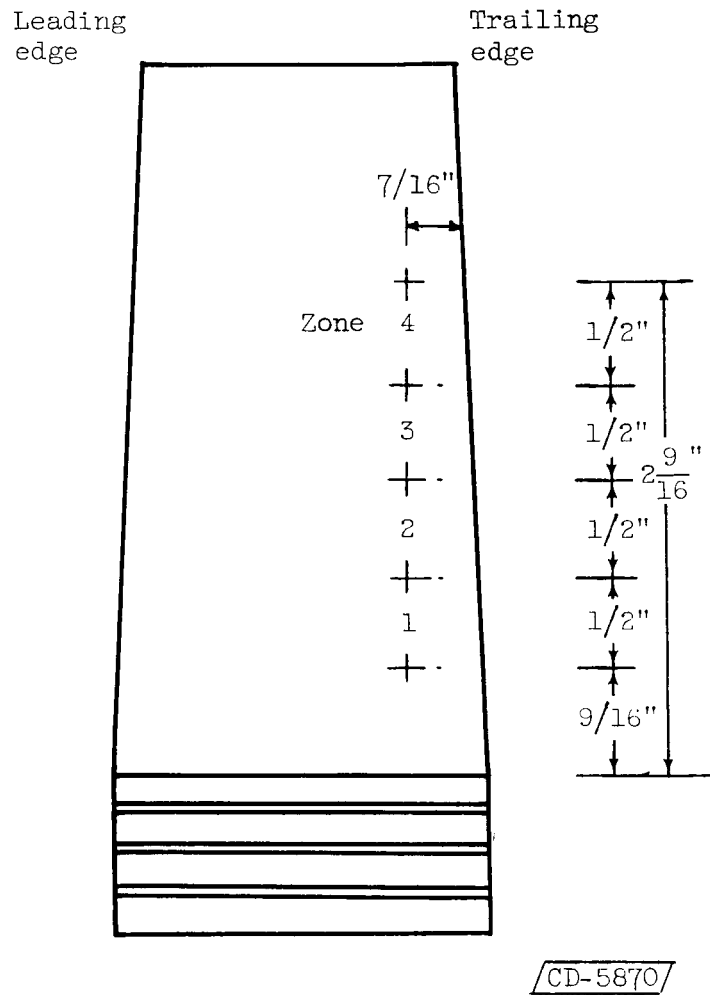
Figure 2. - Scribed bucket for elongation measurements.

Two buckets of each alloy group were scribed near the trailing edge at 1/2-inch intervals, as shown in figure 2. Bucket elongation measurements were made after some necessary shutdowns and at the conclusion of the test. Since the investigation demanded that the engine be operated with as few starts as possible, the engine was never stopped for the sole purpose of bucket inspection. The measurements were made using an optical micrometer having a sensitivity of 0.0001 inch. However, elongation data were influenced by distortion of the buckets and by human error and were therefore considered to be reproducible only to ± 0.001 inch or ± 0.2 percent elongation in each 1/2-inch gage length.

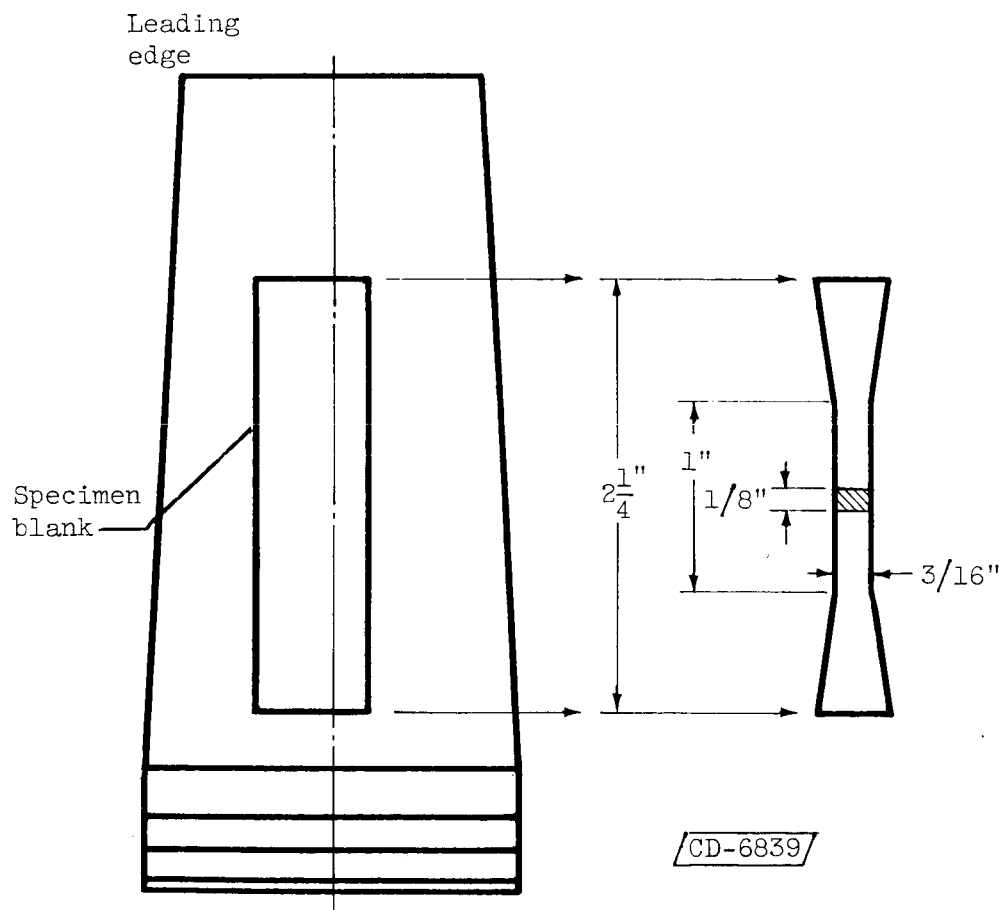
Figure 3. - Bucket airfoil stress-rupture specimen and region of bucket from which it was machined.

Stress-rupture properties of each alloy group were determined from specimens cut from airfoils of untested buckets. The type and size of the specimens and the region of the bucket from which each was machined are shown in figure 3. Rupture tests were performed in air at 1700° F over a range of stresses.

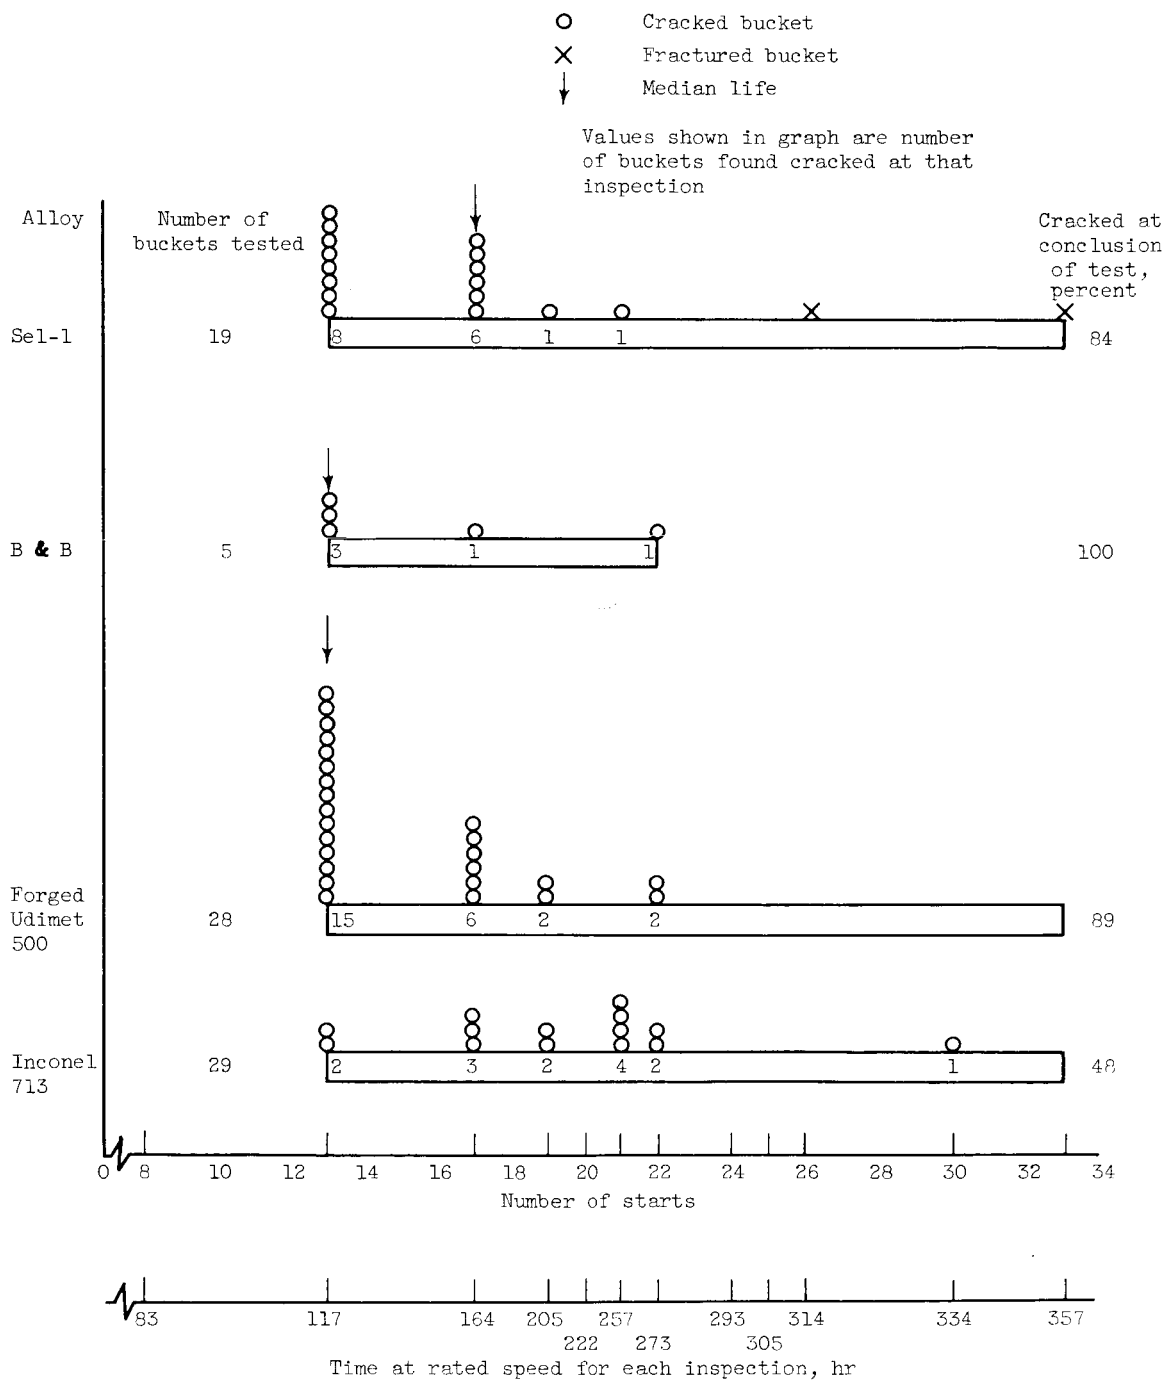
Figure 5. - Number of starts and operating hours when cracks were first found in each bucket.

Thermal-stress fatigue cracking occurred in buckets of all alloy groups. As observed in previous investigations (refs. 1 to 4), these cracks were small and occurred over a considerable length of the bucket leading edge. Typical cracked buckets are shown in figure 4. Bucket failure data are plotted against number of starts in figure 5, since this has been shown (ref. 3) to be the primary cause of thermal-stress fatigue cracking in this engine. The position of each data point indicates the number of starts after which cracks were first observed in each bucket. A nonlinear time scale, showing the hours at rated speed accumulated at each inspection, is also provided for convenience. The figure indicates that no cracking was found after 8 starts and 83 hours at rated speed; however, cracking was noted simultaneously in buckets of all alloy groups after 13 starts and 117 hours at rated speed. More than 50 percent of the buckets of alloys B & B and forged Udimet 500 were cracked at that time. Only four additional starts (total of 17) were necessary to crack more than 50 percent of the buckets of alloy Sel-1. Inconel 713 buckets had a much lower percentage of buckets cracked after a given number of starts. At the conclusion of the test (33 starts and 357 hr at rated speed) from 48 to 100 percent of the buckets in each alloy group had cracked.

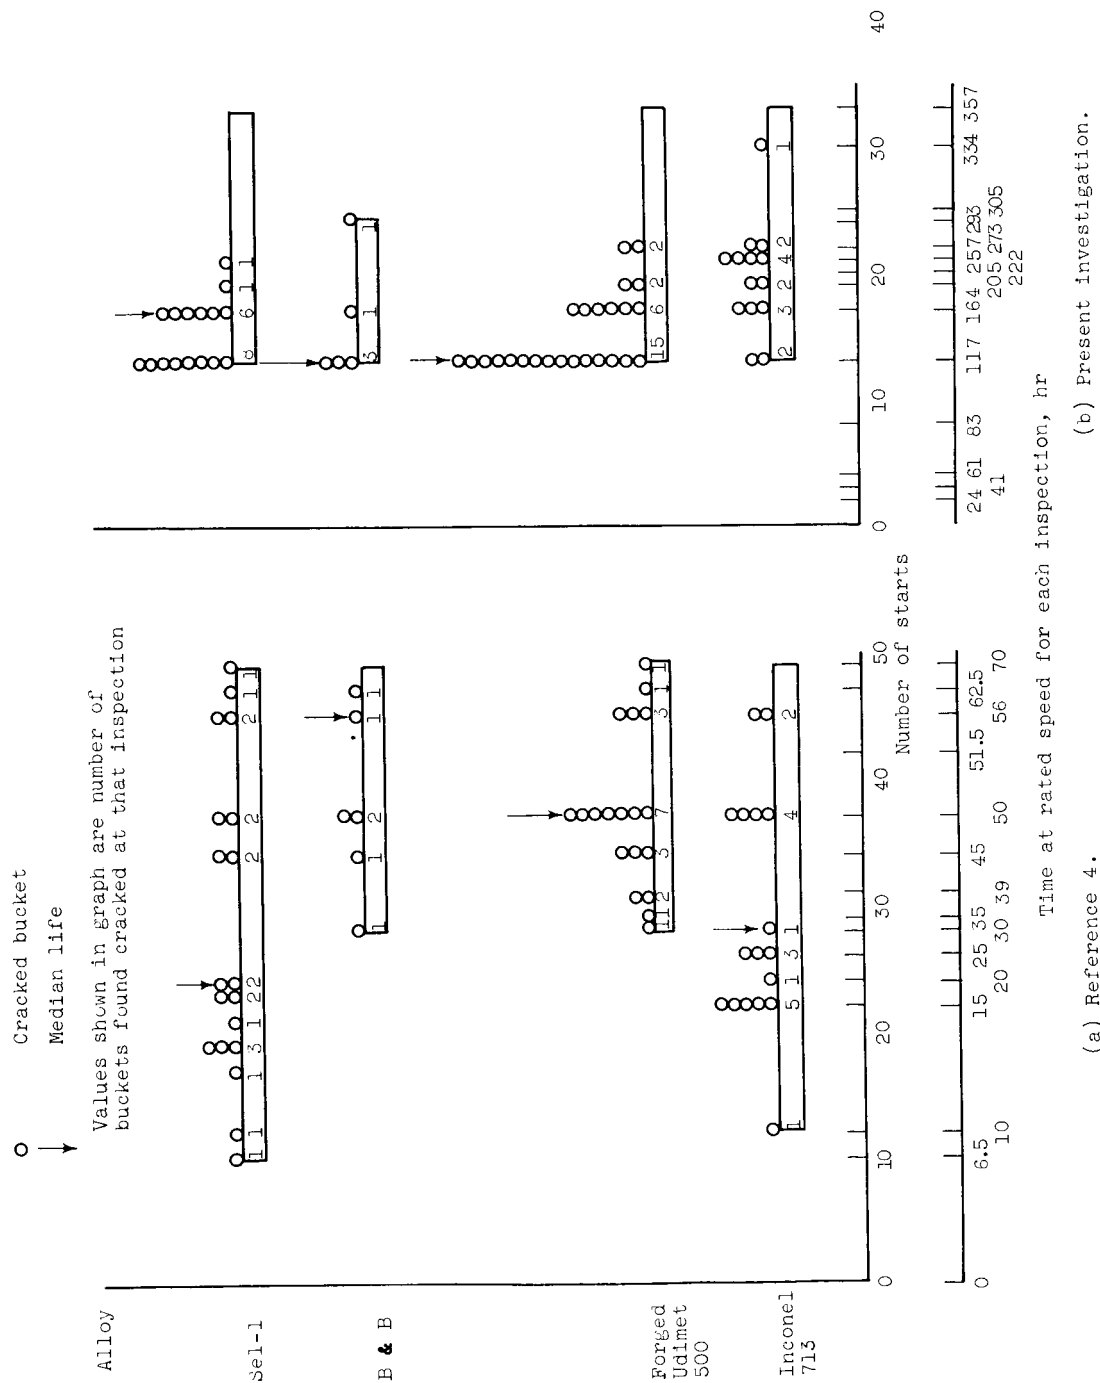
Figure 6. - Comparison of thermal-stress fatigue crack data from previous investigation with data from present investigation.

The effects on bucket failure of increased operating time between starts are indicated by comparison of these data with those of the previous study (ref. 4). These data are shown in table III and figure 6. As indicated previously, buckets for both investigations were from the same lots. The average time at rated speed between starts was about 1.4 hours (49 starts in 70 hr) in the preceding study and about 11 hours (33 starts in 357 hr) in this study. Whereas some buckets from all alloy groups were cracked after 13 starts in this investigation, cracked buckets were

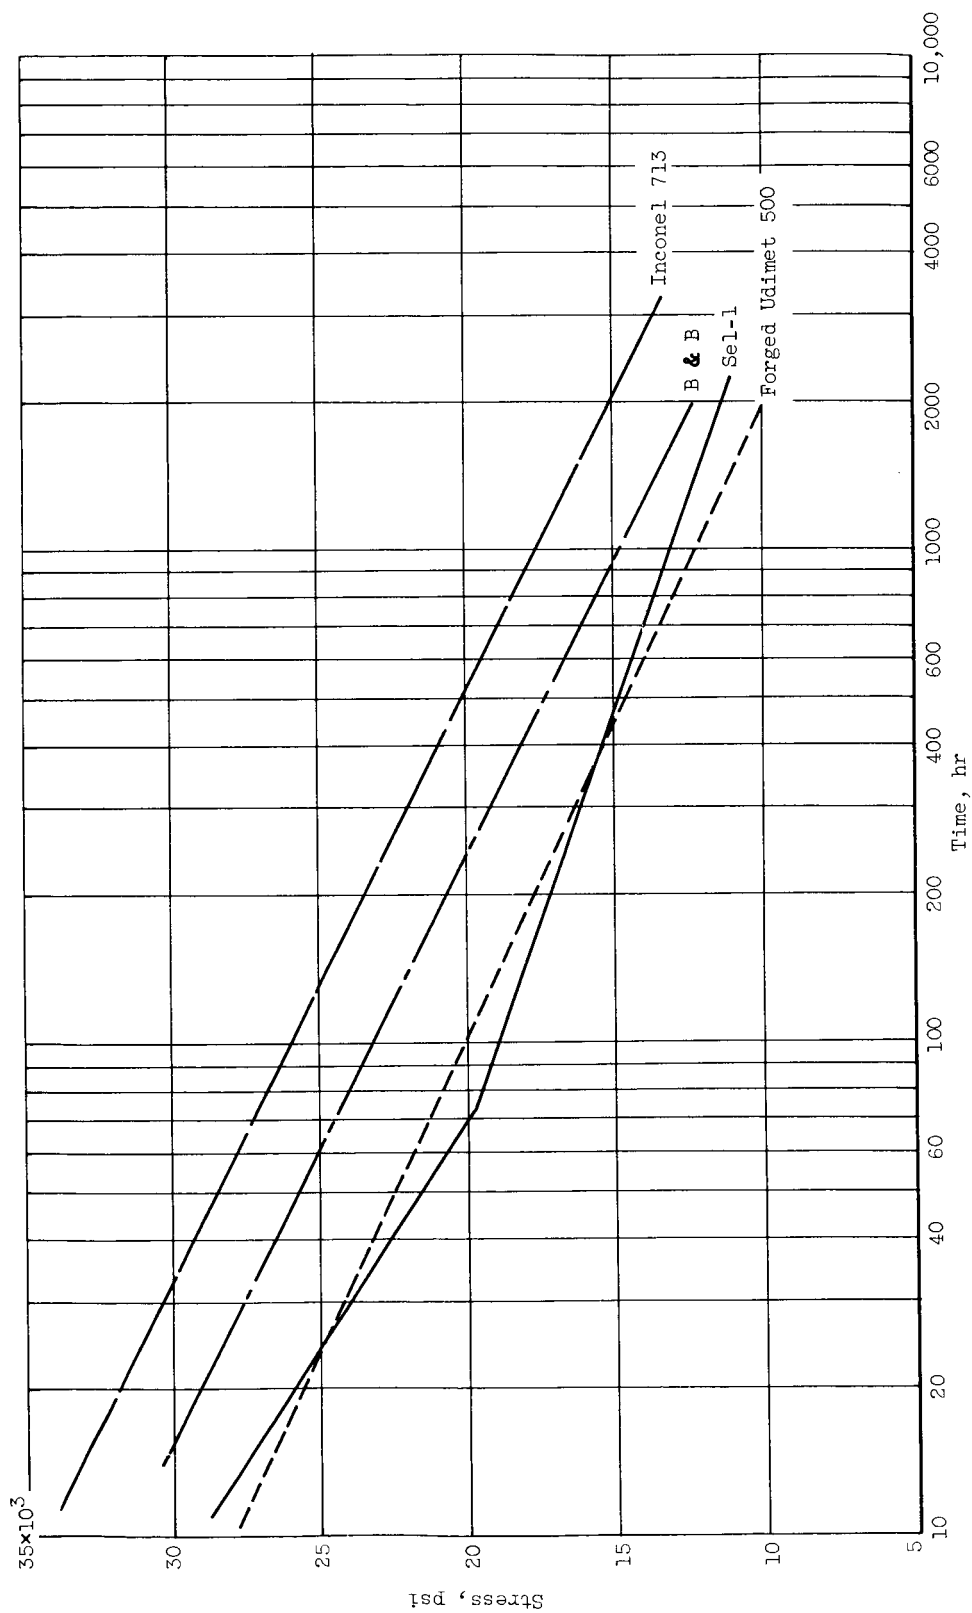
Figure 9. - Stress-rupture life of alloys at 1700° F.

Results of rupture tests run at 1700° F on specimens cut from bucket airfoils are shown in figure 9. Alloys Sel-1 and forged Udimet 500 both showed rupture strength of about 20,000 psi for 100-hour life. B & B alloy showed a higher strength, 23,000 psi, and Inconel 713 had the highest strength, 26,000 psi for 100-hour life.
